Case Study

Fluid & Condition Monitoring Services

REPAIR AFTER FAILURE!

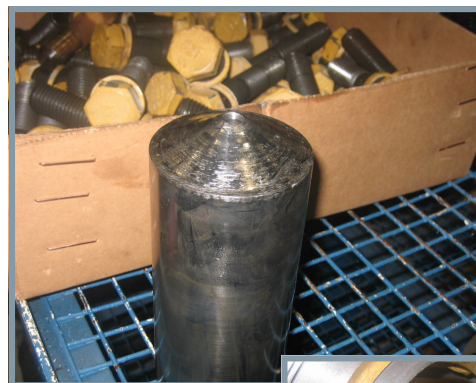
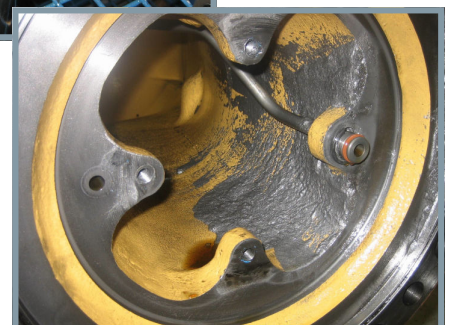
At 11,100 hours the machine had failed. Another inspection revealed liquid metal lining the inside of the front axle. With further investigation, it became apparent that a shaft had come loose and was continuously rubbing against the hub; causing excessive wear and scoring.

If the customer had chosen to repair when advised it would have been a relatively cheap repair. The cost of replacing the seals and bearings at 8,000 hours would have worked out at £1.39 per hour.

the cost of repair at 11,100 hours worked out at £2.22 per hour due to additional work to repair the hub.

If left, this issue would have inevitably caused damage to the gear surfaces necessitating replacement of the gears. If this was the case, in addition to replacing the seals and bearings, repairing/replacing the hub, the total repair cost for the customer would have been £3.30 per hour.
